Monthly Oversight Report 45
ACS NPL Site
Griffith, Indiana
August 28, 2004 - September 24, 2004

USEPA/RAC VII
American Chemical Services RAO (057-ROBF-05J7)

Subject: Monthly Oversight Summary Report
No. 45 for September 2004

Monthly Oversight Summary Report No. 45
ACS Superfund Site WA57, 46526.238

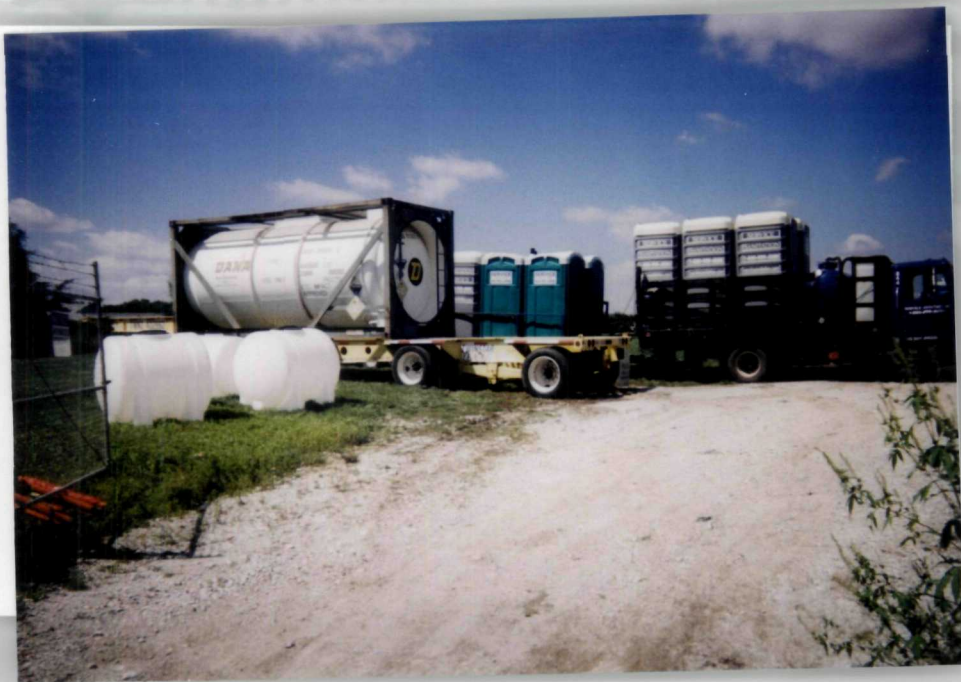
Description: Photo facing west showing trailer-mounted tank of peroxide and mixing tanks for use with modified Fenton's reagent injection. Also, Port-A-Potty delivery in background.

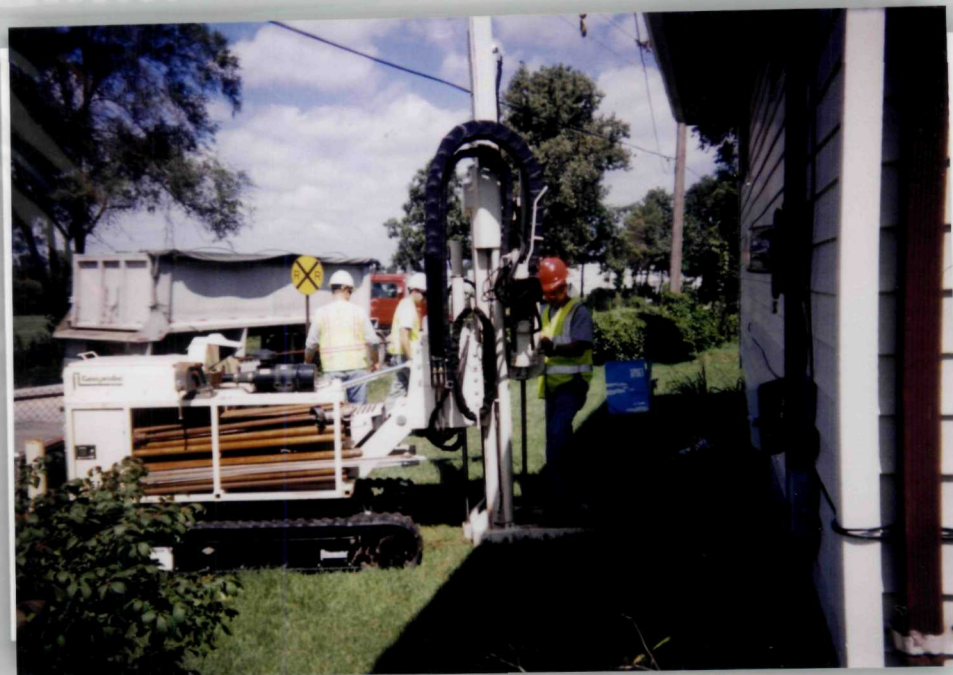
Description: Photo facing north showing Boart Longyear pushing ACS-SG-SP01 probe on west side of house at 1002 Reder Rd. to collect soil gas sample.

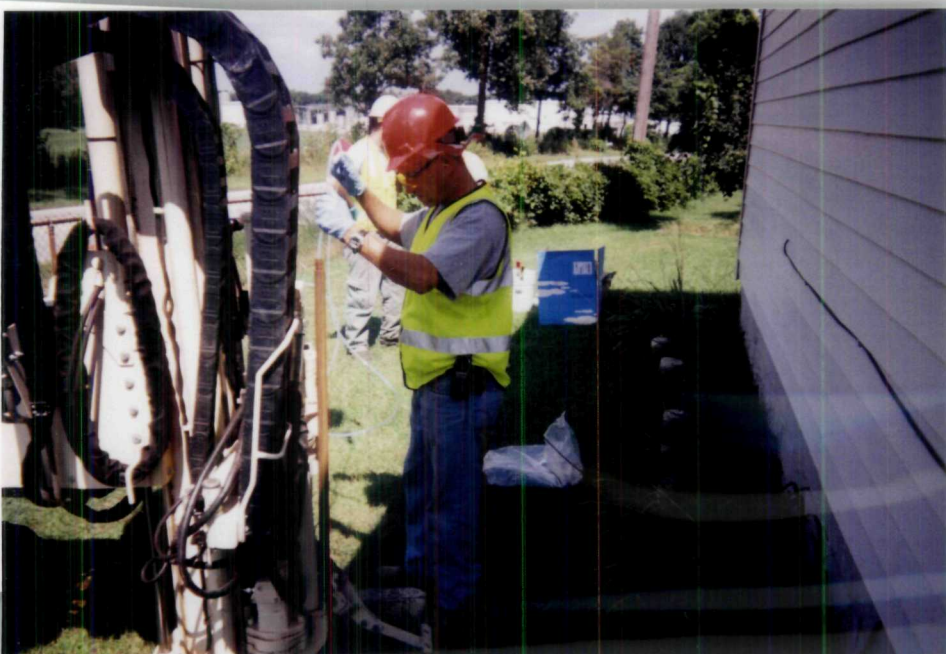
Description: Photo facing north showing Boart Longyear inserting poly sampling tube into drill rods to collect soil gas sample.

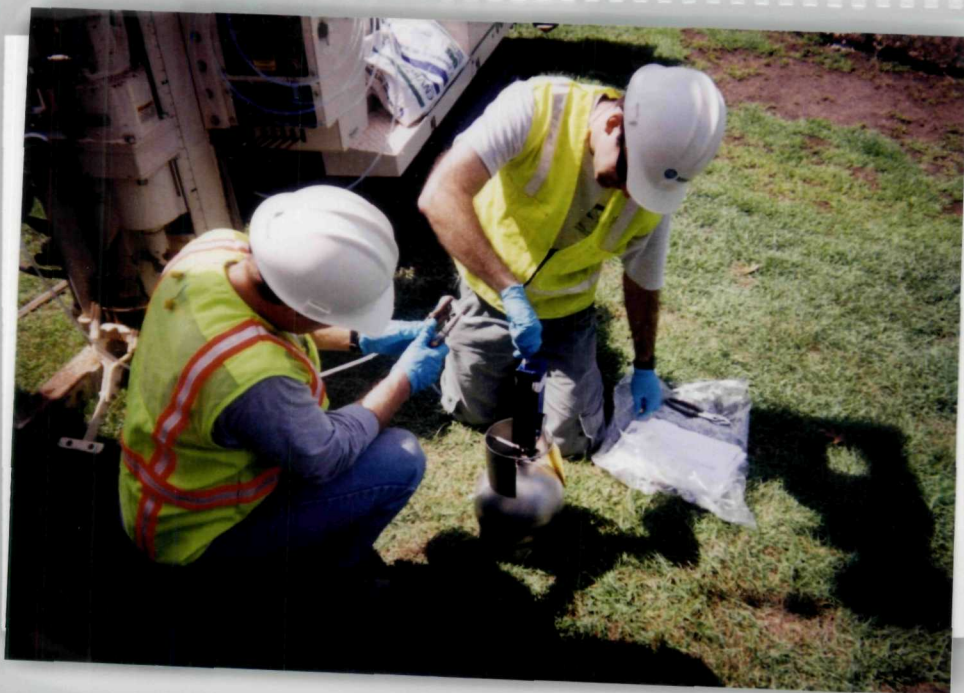
Site: American Chemical Service, Inc.
 Proj. #: 46526
 Roll: 62 Photo #25
 Date: 08-30-04 Time: 1237
 Photographer: Larry Campbell
 Description: Photo facing southwest at MWH connecting sampling tubing to summa canister to collect soil gas sample.

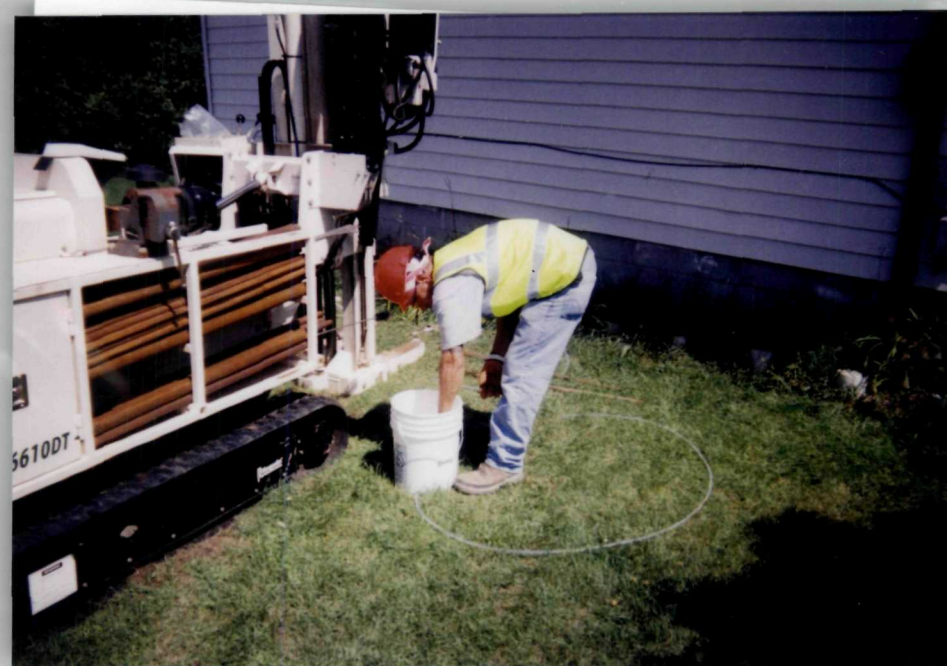
Site: American Chemical Service, Inc.
 Proj. #: 46526
 Roll: 62 Photo #26
 Date: 08-30-04 Time: 1320
 Photographer: Larry Campbell
 Description: Photo facing northeast showing Boart Longyear deconning rods prior to next sampling location.

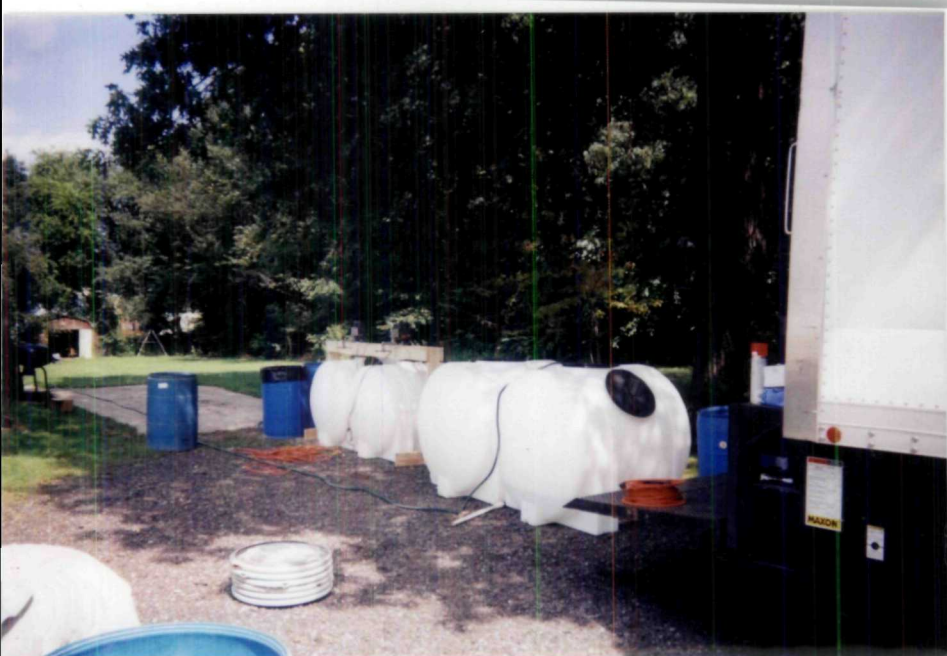
Site: American Chemical Service, Inc.
 Proj. #: 46526
 Roll: 62 Photo #27
 Date: 08-30-04 Time: 1343
 Photographer: Larry Campbell
 Description: Photo facing northeast showing Isotec mixing tank setup for modified Fenton's reagent injection. Filling tanks with water.

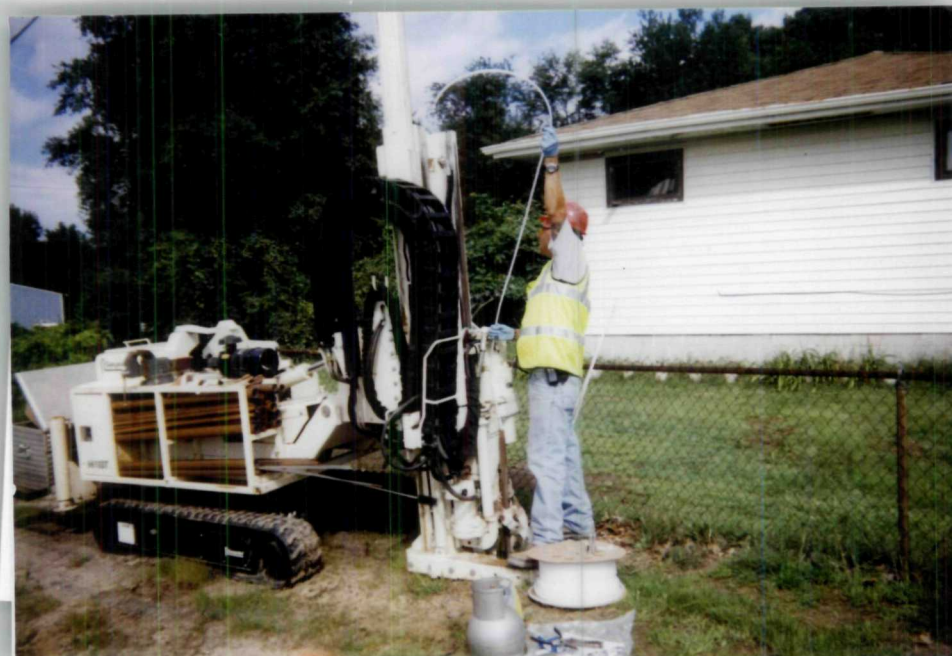
Site: American Chemical Service, Inc.
 Proj. #: 46526
 Roll: 63 Photo #1
 Date: 08-30-04 Time: 1530
 Photographer: Larry Campbell
 Description: Photo facing northeast showing Boart Longyear installing poly tubing into ACS-SG-SP02 soil gas probe.

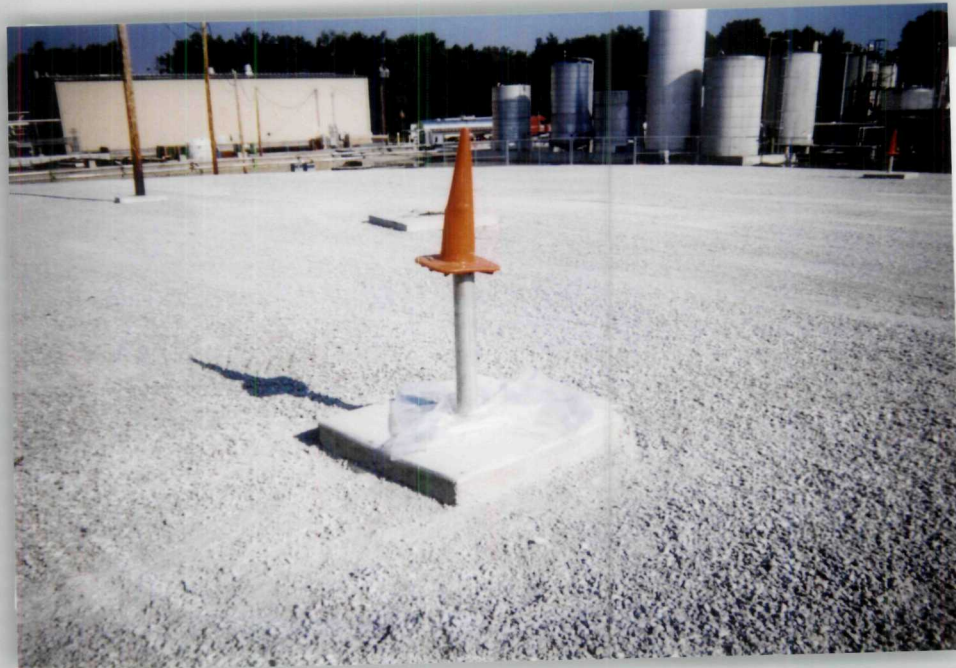
Description: Photo facing northwest showing new concrete pad at the new well SVE59.

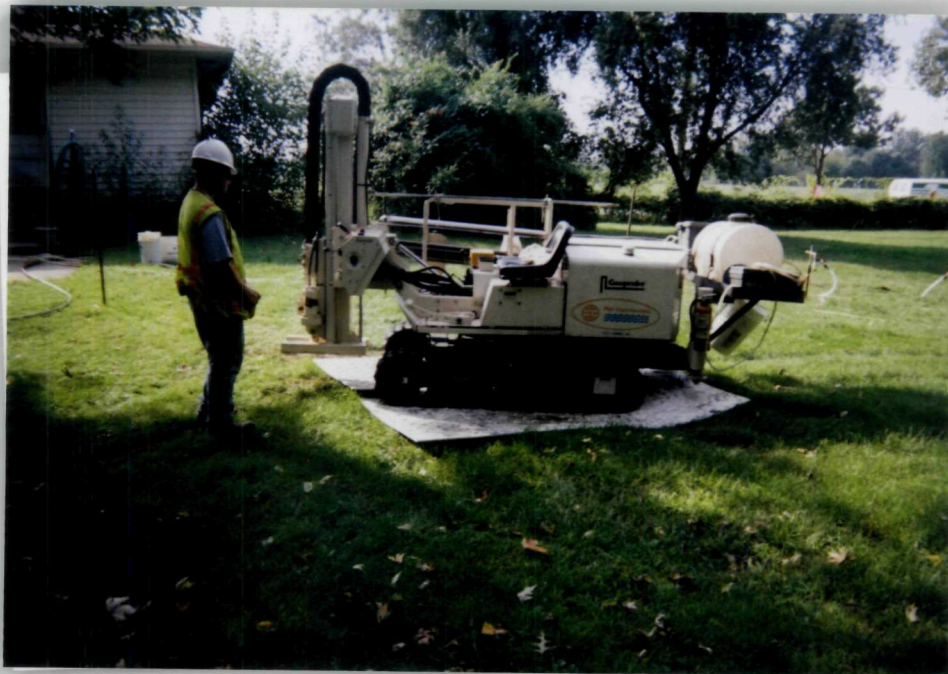
Description: Photo facing west showing PSA maneuvering rig via remote control and using mats to avoid damage to yard when turning rig.

MWH plans to fix damage to the grass resulting from the Chem Ox injection work September 20th.

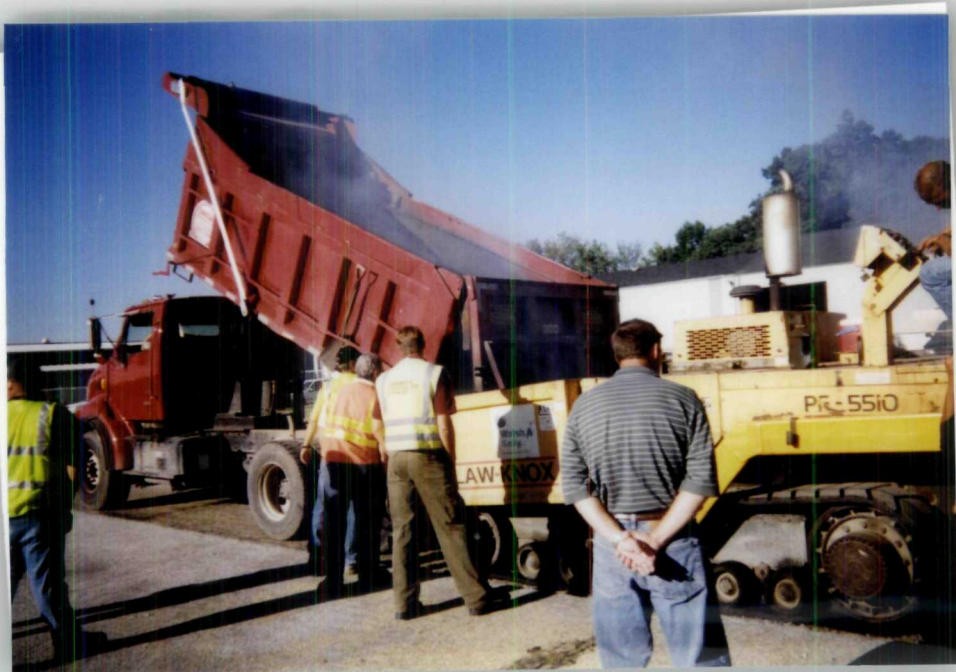
Description: Photo facing north showing Walsh & Kelly (W&K) roller preparing the asphalt concrete test pad base at the Griffith airport.

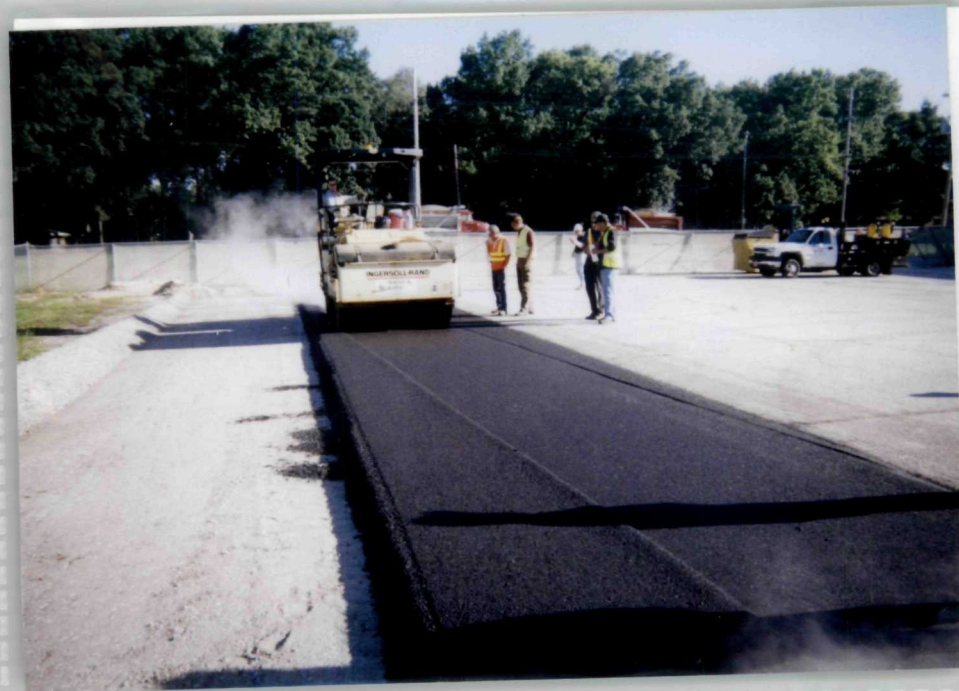
Site: American Chemical Service, Inc.
 Proj. #: 46526
 Roll: 63 Photo #22
 Date: 09-07-04 Time: 0824
 Photographer: Larry Campbell
 Description: Photo facing south showing placement of
 asphalt concrete in test pad.

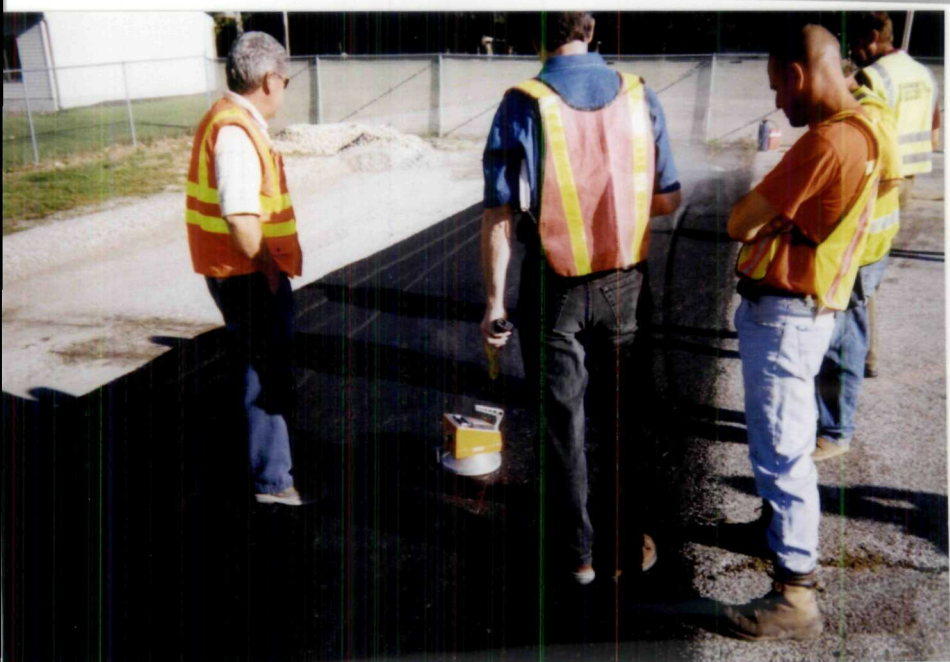
Site: American Chemical Service, Inc.
 Proj. #: 46526
 Roll: 63 Photo #23
 Date: 09-07-04 Time: 0827
 Photographer: Larry Campbell
 Description: Photo facing north showing steel-drum
 roller compacting asphalt concrete in test
 pad.

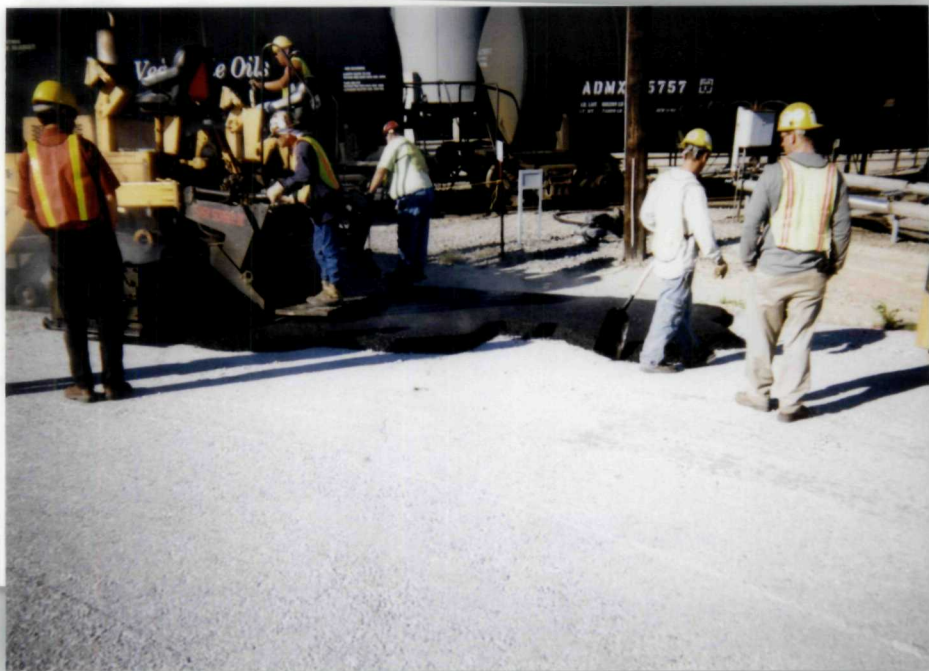
Description: Photo facing northwest showing W&K spaying asphalt on edge of concrete pad so asphalt concrete will adhere to the concrete.

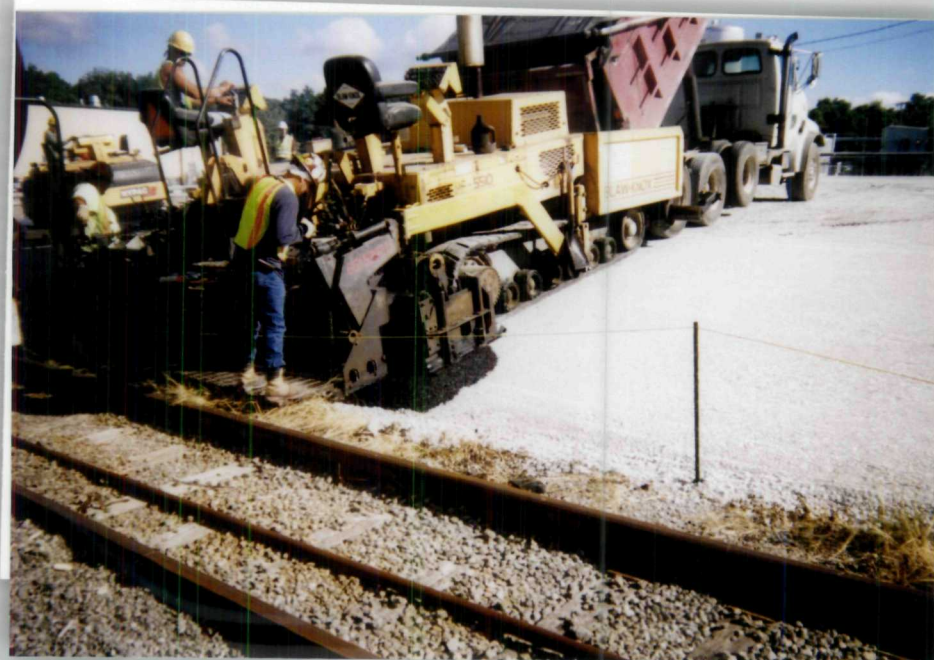
Description: Photo facing southeast showing Trugreen truck spraying herbicide on gravel to eliminate potential plant growth beneath asphalt concrete.

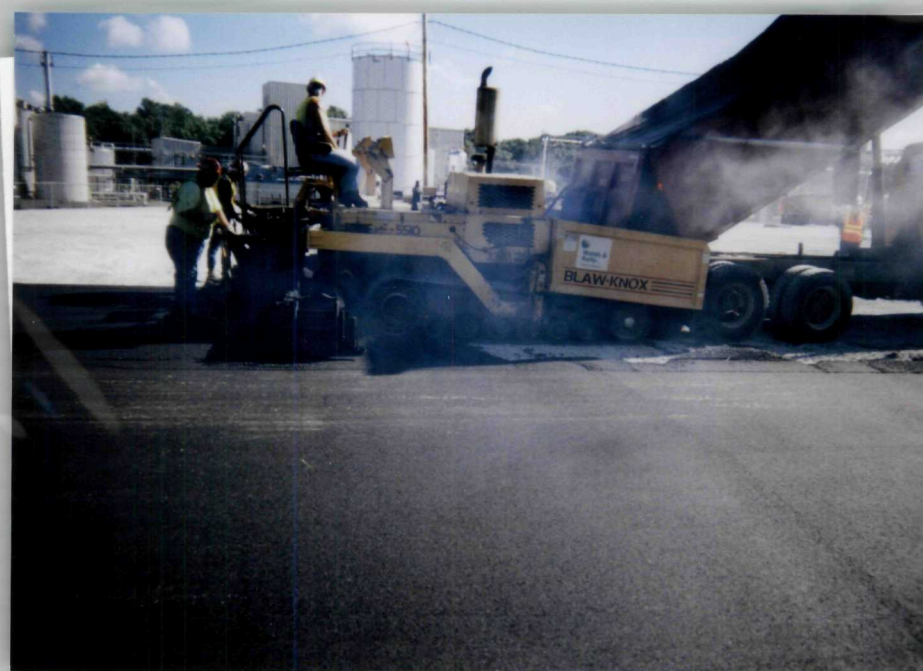
Description: Photo facing east showing first E-W panel being placed to join the initial upslope N-S panels. Must keep alternating placement orientation to avoid "cold" joints.

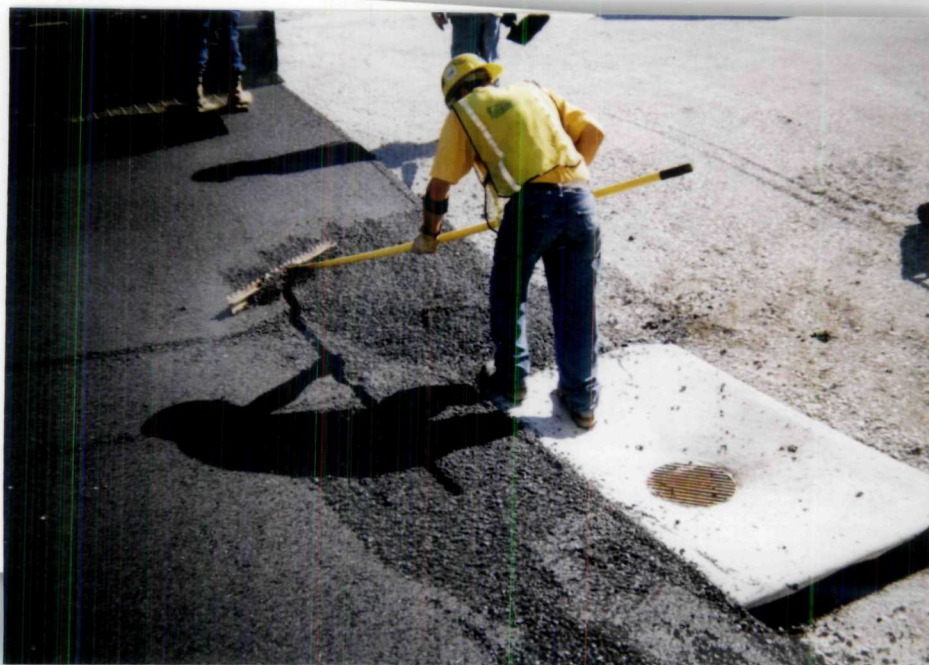
Description: Photo facing north showing paver placing first E-W panel. Initial upslope panels are in foreground.

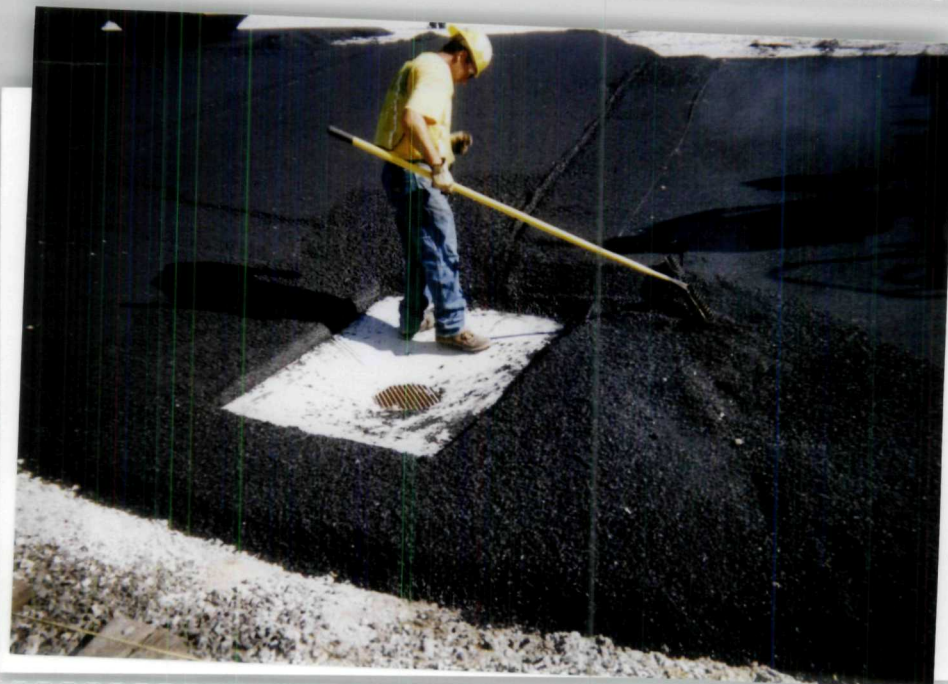
Roll: 64 Photo #17

Description: Photo facing northwest showing laborer raking and leveling asphalt concrete around catch basin pad. Same pad as in Photo #17.

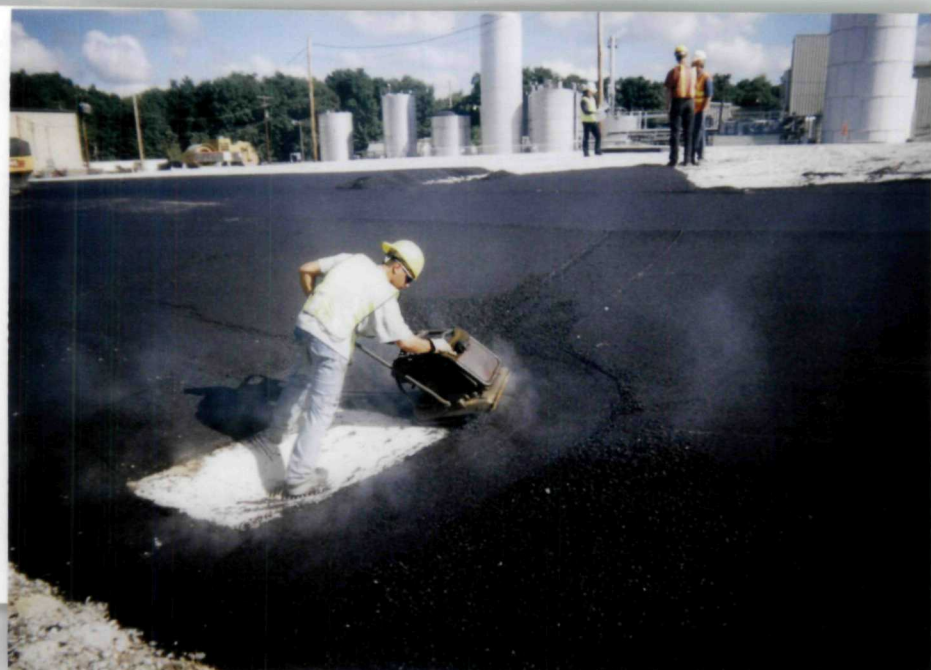
Description: Photo facing northwest showing laborer compacting asphalt concrete around catch basin pad using vibratory plate compactor.

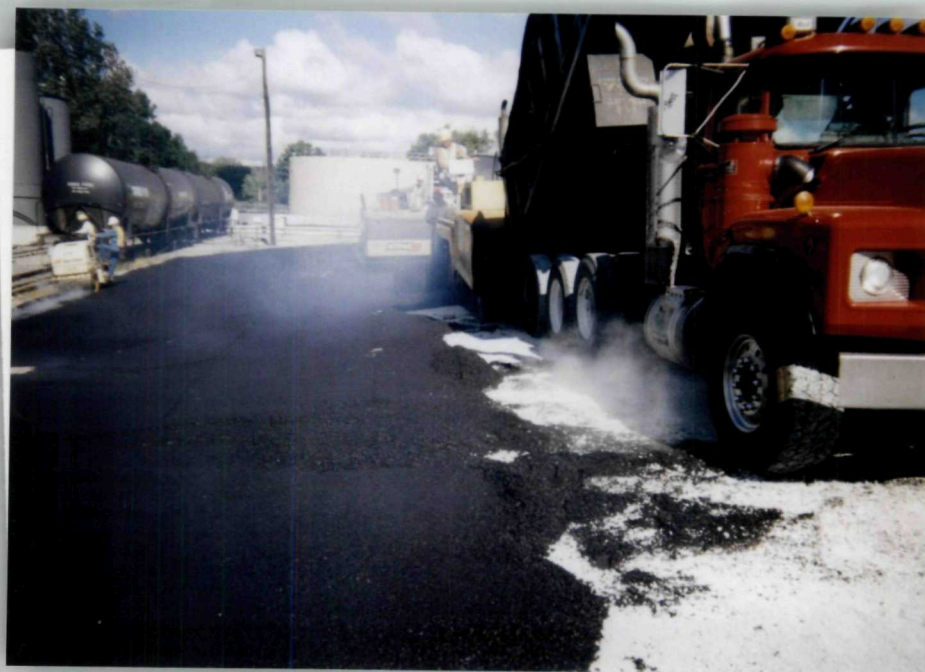
Description: Photo facing west showing paver placing E-W panel at top of initial upslope N-S panels.

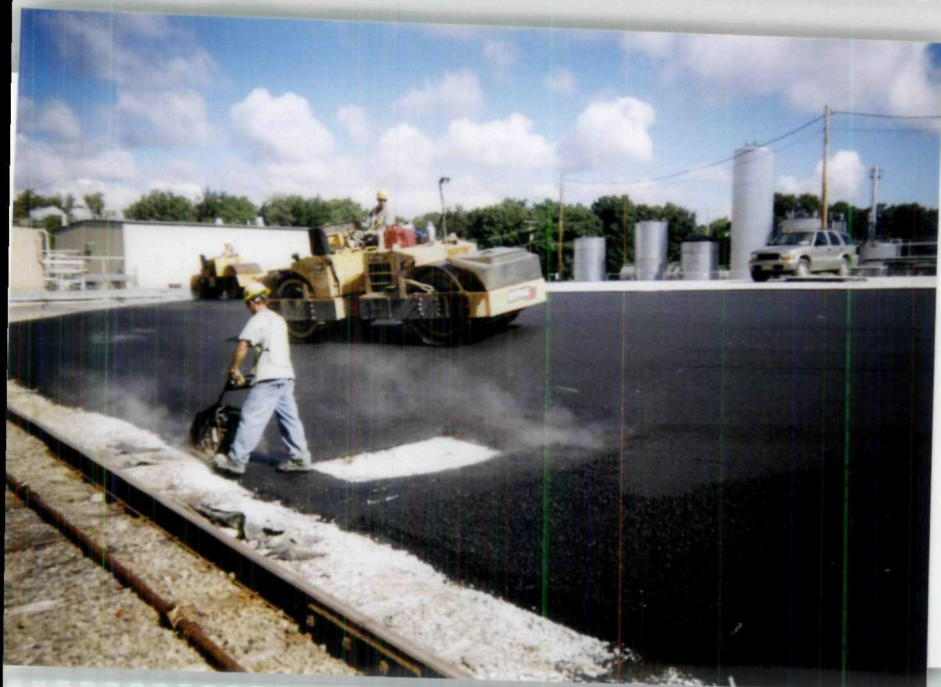
Description: Photo facing northwest showing various compactors rolling (compacting) asphalt concrete in southwester quadrant of SBPA final cover.

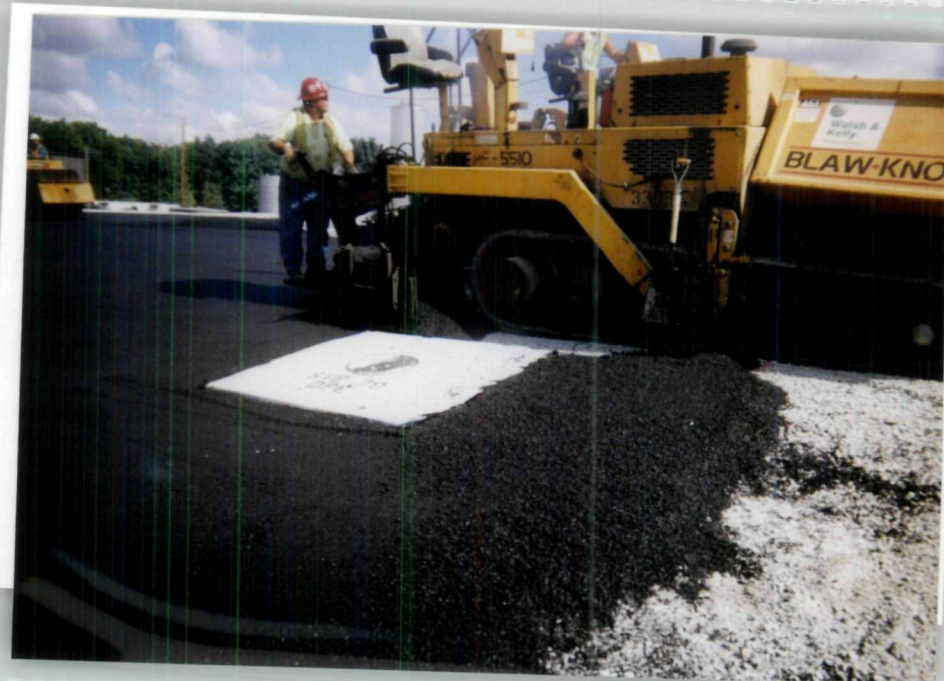
Description: Photo facing northwest at paver placing asphalt around SVE79 concrete pad.

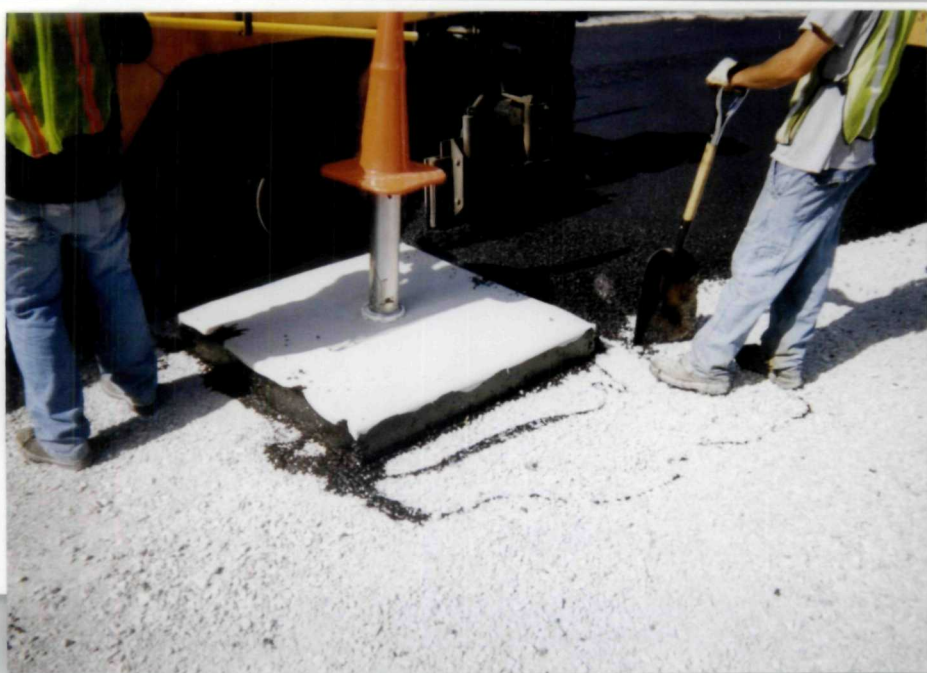
Description: Photo facing southwest showing paver placing asphalt concrete around SVE71 concrete pad.

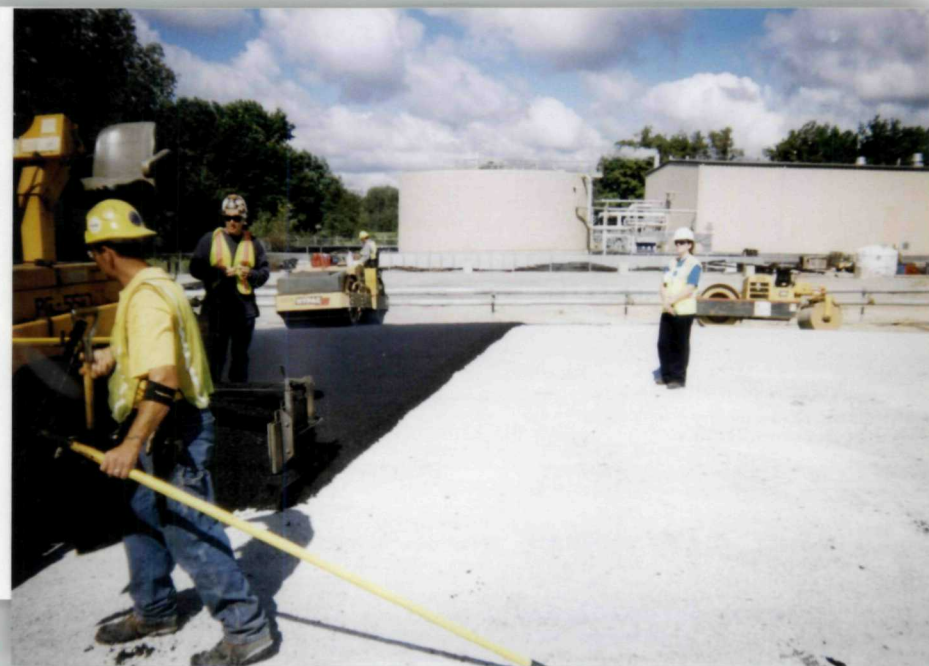
Description: Photo facing west showing E-W panel on west end of SBPA. Temperature of AC as placed = 330°F.

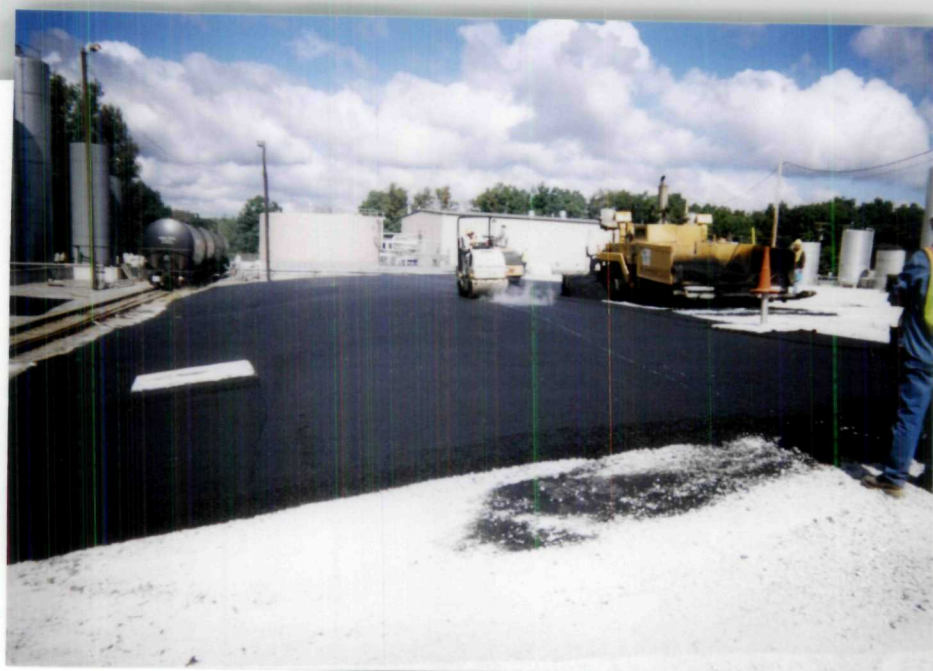
Site: American Chemical Service, Inc.
 Proj. #: 46526
 Roll: 64 Photo #25
 Date: 09-08-04 Time: 1050
 Photographer: Larry Campbell
 Description: Photo facing west showing asphalt cement cover on southwest quadrant of SBPA.

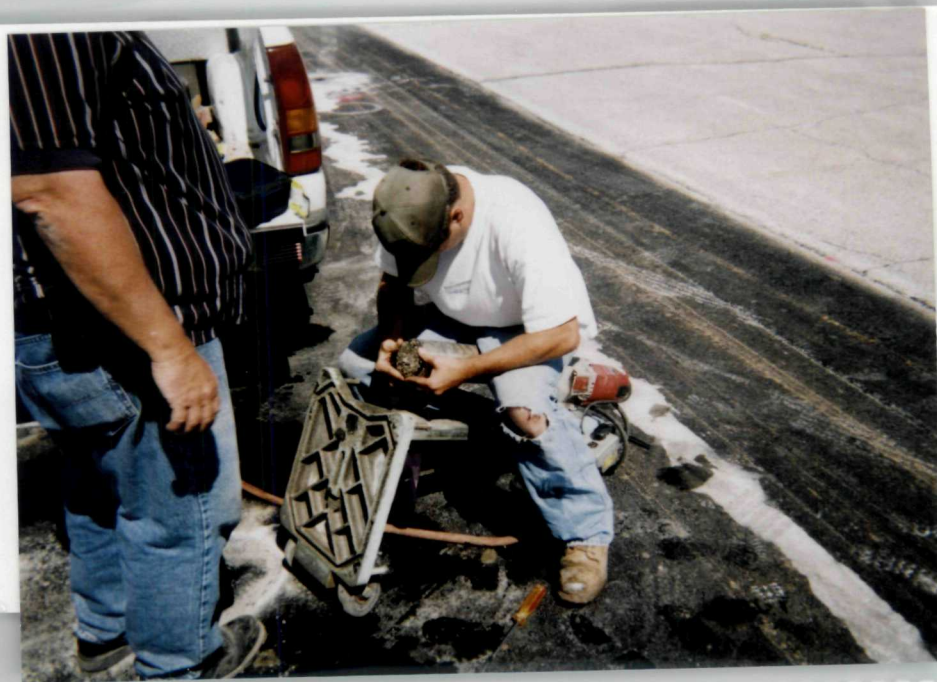
Site: American Chemical Service, Inc.
 Proj. #: 46526
 Roll: 65 Photo #5
 Date: 09-08-04 Time: 1231
 Photographer: Larry Campbell
 Description: Photo facing north showing W&K
 attempting to remove core from bit. Difficult
 to remove because of high asphalt content
 of mix.

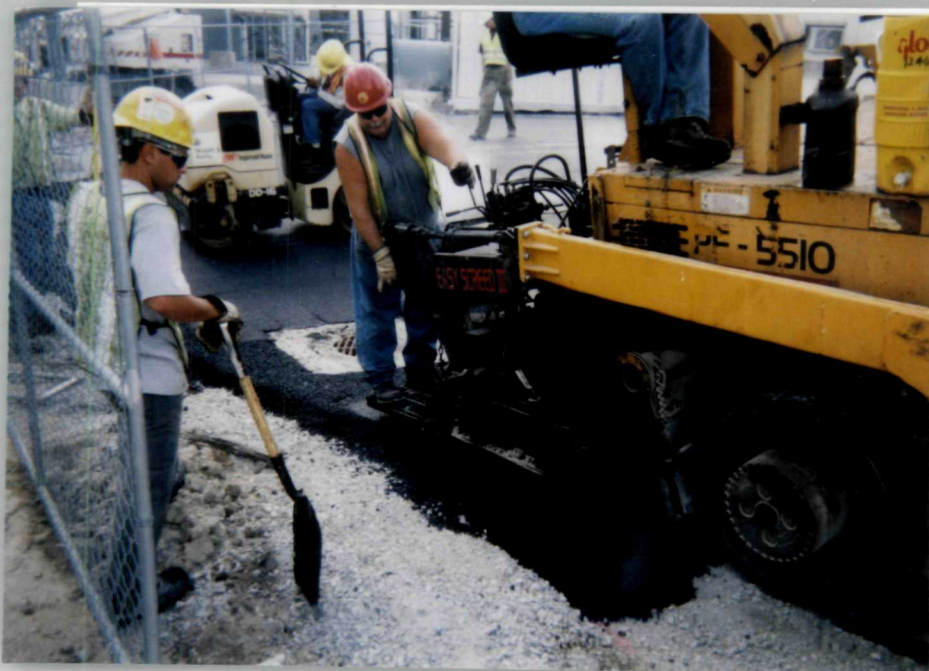
Description: Photo facing west showing 2" thin lift (R) and milled edge (L) which will be used to make "cold" joint with today's paving. Note asphalt tack coat on milled edge.

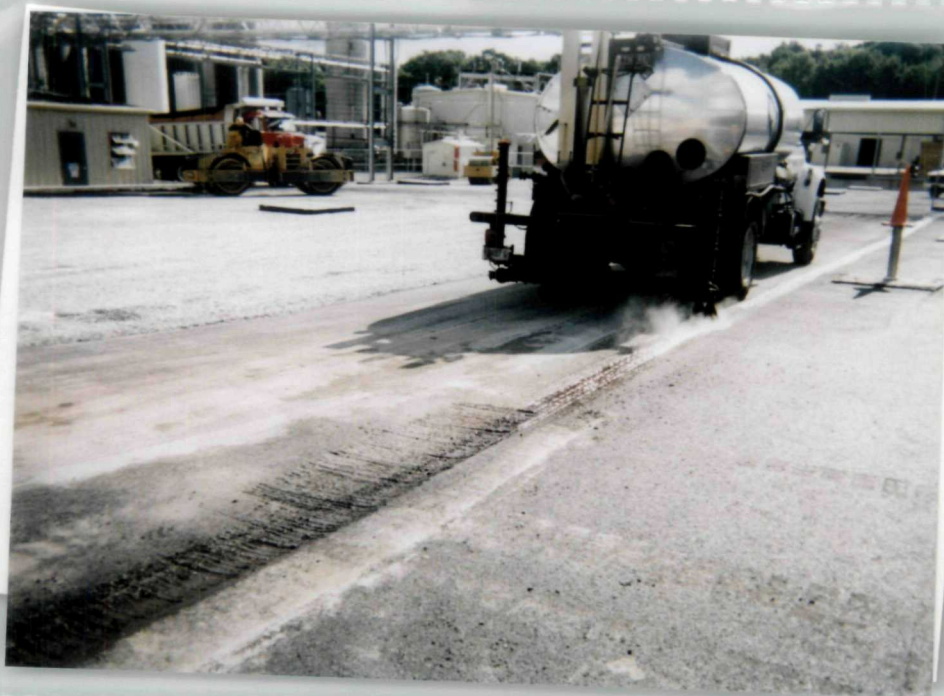
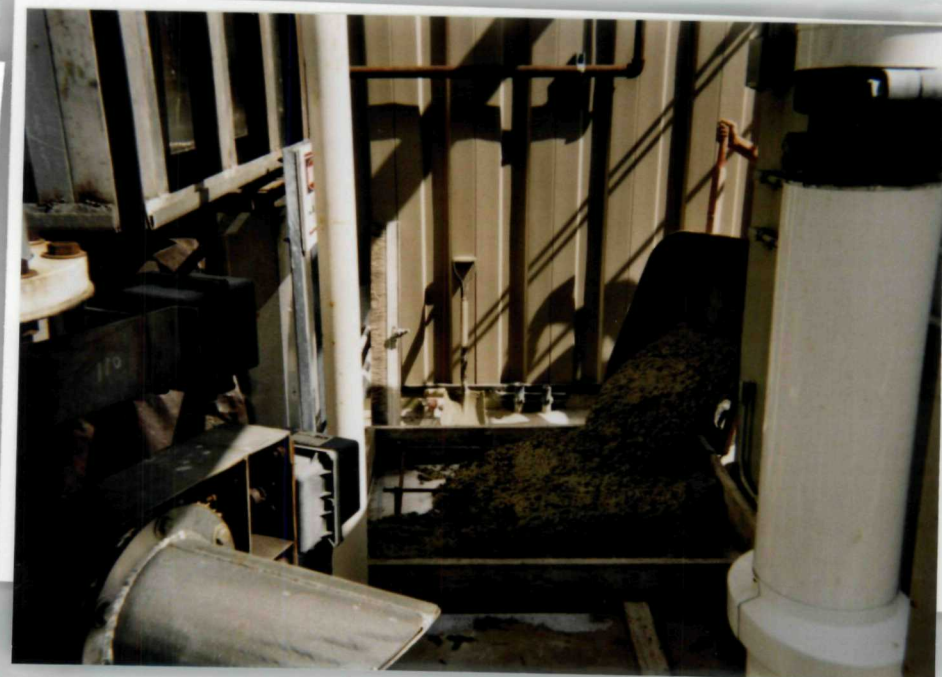
Description: Photo facing north showing Ryan placing concrete in forms for new knockout tank foundation pad.

On September 9, Ryan formed and poured a reinforced concrete pad between the thermox 1 heat exchanger and the chemical oxidization unit at the location of a new stainless steel knockout tank to be installed for collection of liquids condensing in the ISVE vapor conveyance piping. On September 13, Ryan used a crane to lift and place the knockout tank on this pad and subsequently connected the vapor piping to the tank.

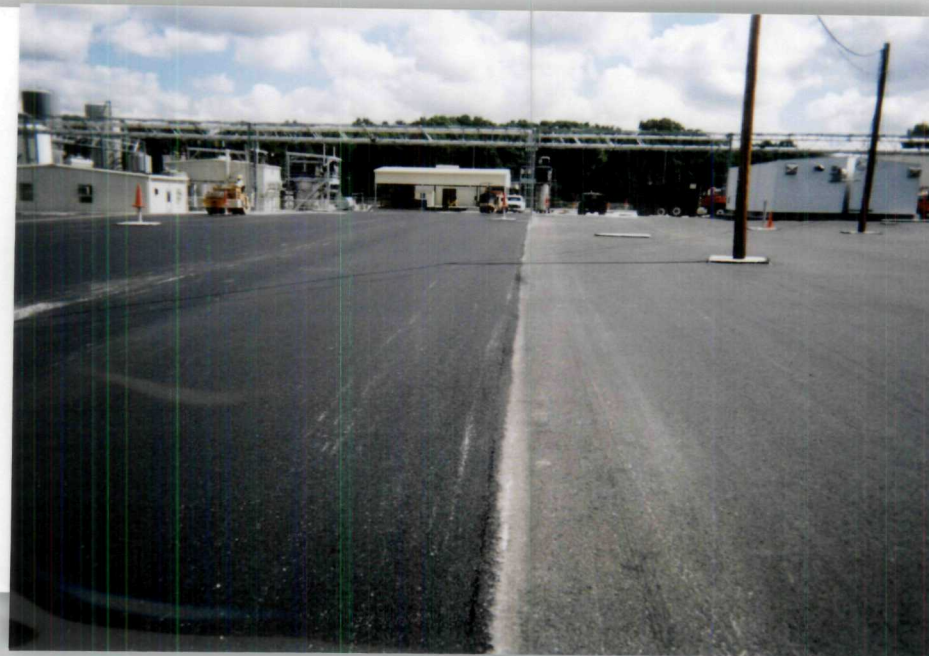
Description: Photo facing west showing paving on west end of SBPA cover. Note tack coat of asphalt on left prior to placement of asphalt concrete to form "cold" joint.

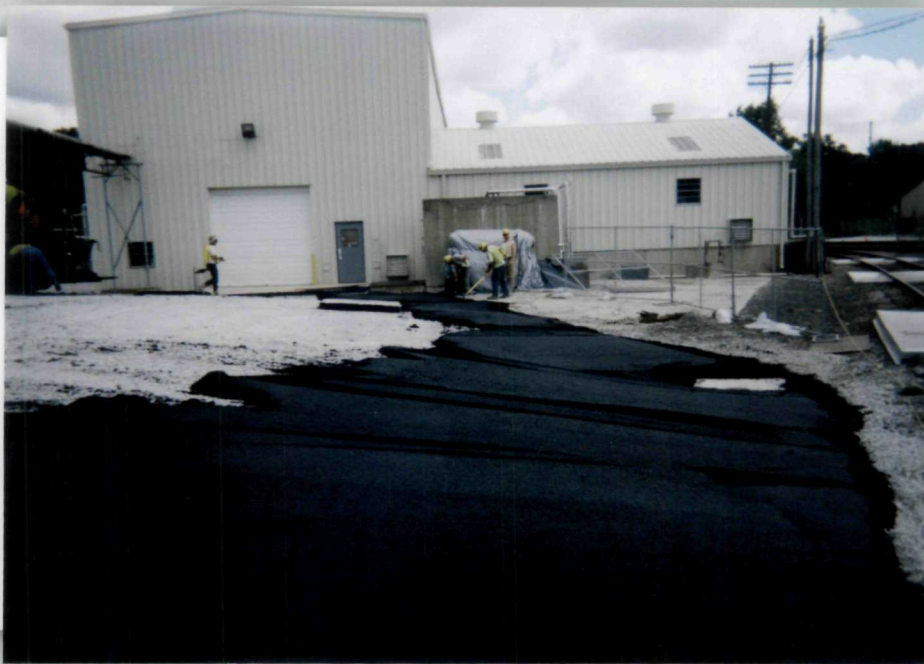
Description: Photo facing east showing completed asphalt panels in west end of SBPA cover. Linear feature is "cold" joint - today's paving on L, yesterday's on R.

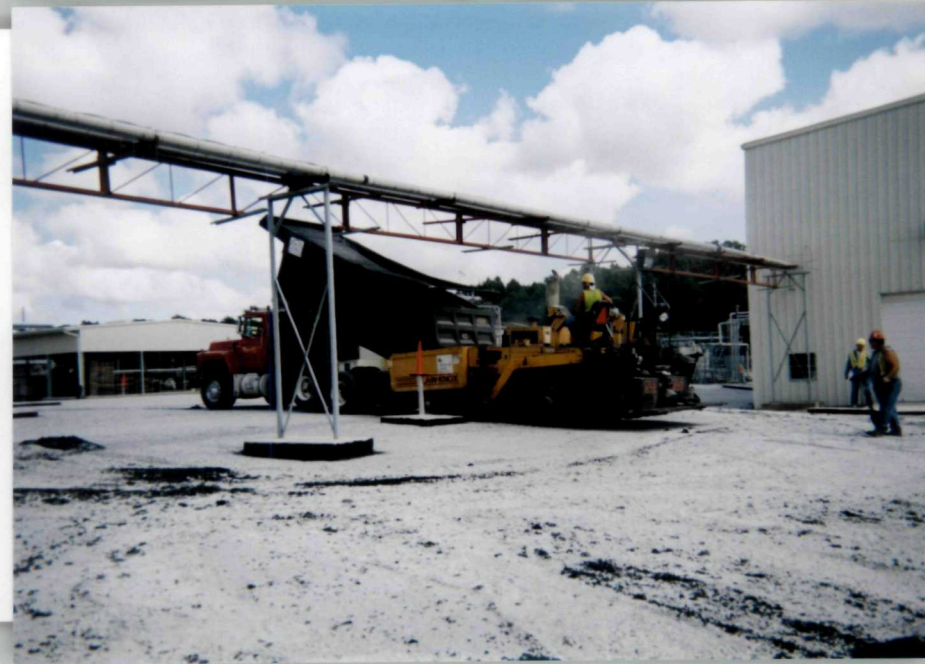
Description: Photo facing east showing initial N-S upslope panes in southeast quadrant of SBPA cover.

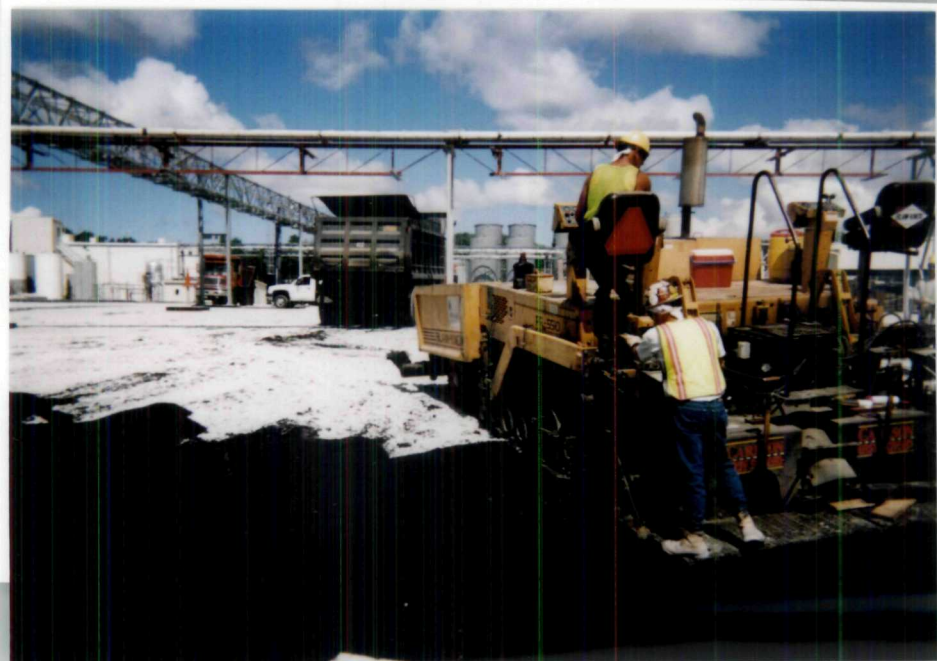
Roll: 65 Photo #17

Description: Photo facing northeast showing paver receiving load of asphalt concrete so truck can dump without hitting overhead pipes. Will place AC 50' behind paver's location.

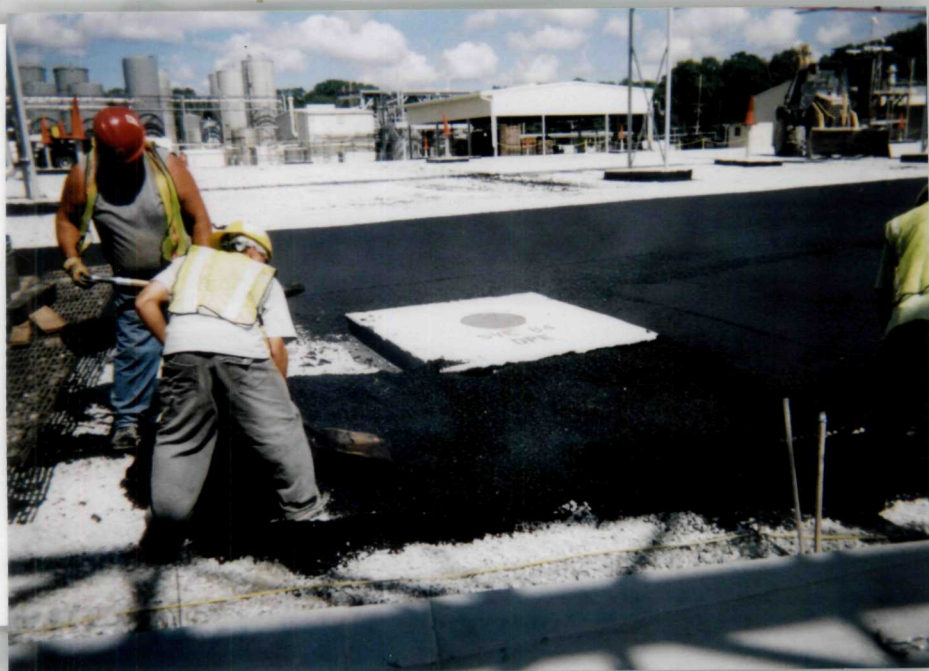
Description: Photo facing east showing paver placing E-W tie panel at top of the N-S upslope starter panels.

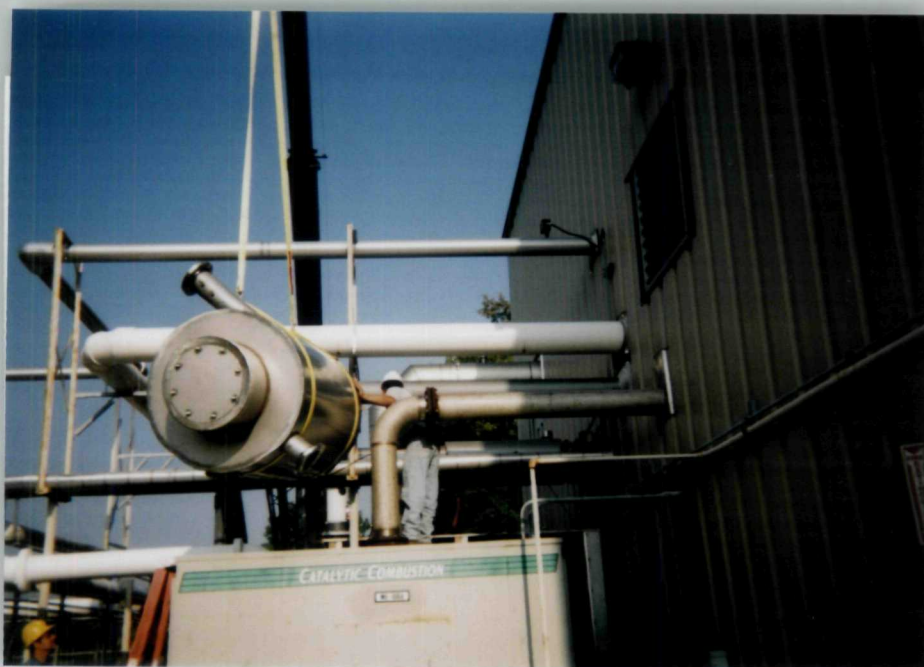
Description: Photo facing southeast showing new heat exchanger for thermox 1, manufactured by Global.
